Maintenance and Repair of Concrete Structures
Prof. Radhakrishna G. Pillai
Department of Civil Engineering
Indian Institute of Technology – Madras

Lecture – 33
Cathodic Protection in Concrete Structures-Laboratory and Field Studies

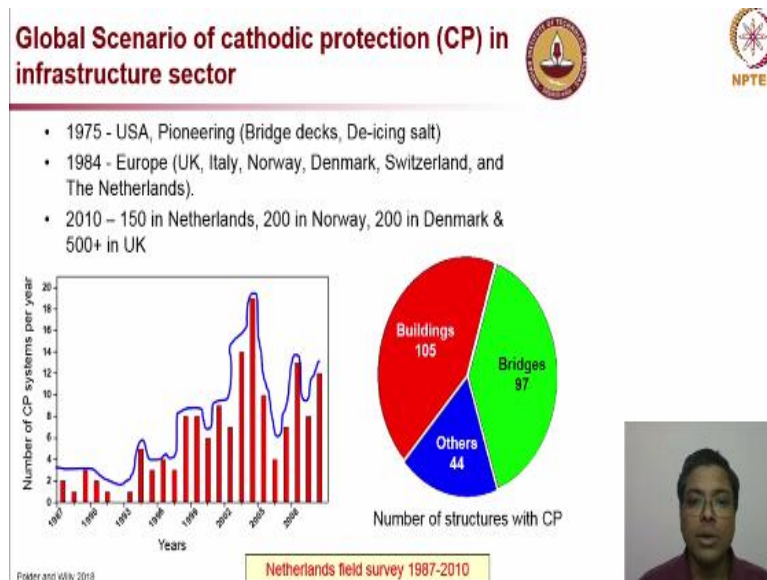
Now the global scenario of cathodic protection in infrastructure sector. If you look at the bar chart at the bottom, you will see that the data going all the way from 1987 until about 2010.

You can see that there is a significant increase in the number of CP systems installed, you can see some variations, but that may not be the reality, it might be just the lack of data available or data collected.

And, so, there is an increase in the use of cathodic protection systems both in US, Europe and also in Netherlands. The pie-chart on the right side is actually showing the distribution among different type of structures, which have cathodic protection system. So you can see that buildings and bridges are almost similar, but one should notice that, in the bridges, the impact of this cathodic protection on the long life, on the economy, etc., is much more in case of bridges as compared to buildings. So this data, both this bar-chart and the pie-chart are showing the data from one field survey conducted in Netherlands.

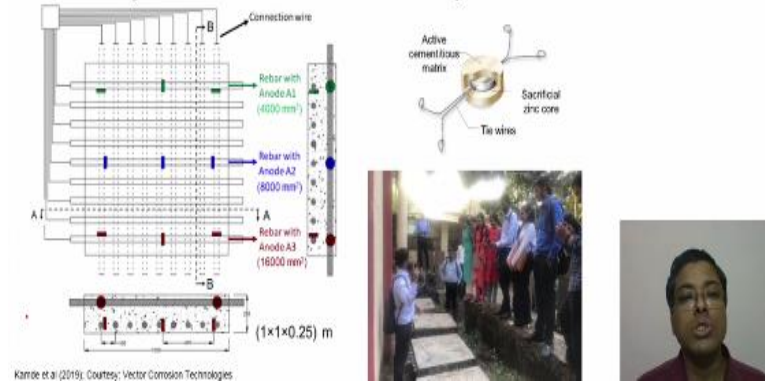
- Specimens were cast by Dr. George Sergi of Vector Corrosion Technologies (about a decade ago)
- Now being monitored in the Concrete Lab at IIT Bombay

Now let us go through the first case study which is a lab study. We have some data on this. So these specimens were cast by Dr. George Sergi, who is a pioneering figure in cathodic protection technology, and he is from Vector Corrosion Technologies and he cast 4 slab specimens which you can see on the screen at the bottom right, and in Mumbai and these are about 12 years old right now.

And you can how the slab specimen looks like. It is about 1 m x 1 m slab and about 250 mm thick. 3 types of anodes are installed or embedded in these slabs. One with 4000 mm² (Anode A1) and another with 8000 mm² (Anode A2) and then 16,000 mm² (Anode A3); these are A1, A2, A3 type anodes as it is mentioned on the screen.

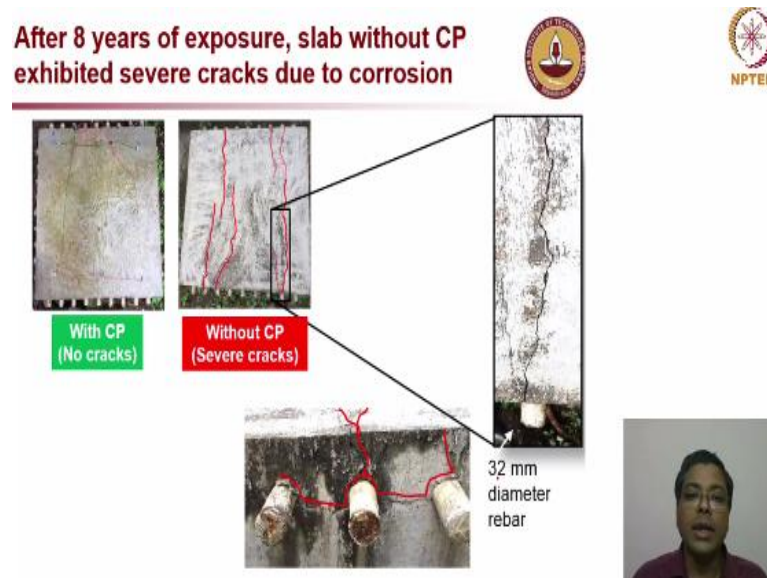
Now here you have visual observation. On the left side is the representative image of Slabs 1, 2, and 3. You can see one of the slab images is shown with cathodic protection. No cracks at all, that means very low corrosion rate, very positive half-cell potential and at the same time no crack, which is demonstration, very clearly telling that it does not really corrode and it helps the steel from corroding.

Whereas on the right side you can see the slab without the cathodic protection, that is Slab 4, as mentioned in the previous slides, and heavy corrosion on that, along the reinforcement line. So you can see on the right side the zoomed-in image which shows very wide crack along the reinforcement, and also about to spall and delamination is also very clear as you see in the picture on the bottom side, the red curve on that, indicates basically the crack locations.

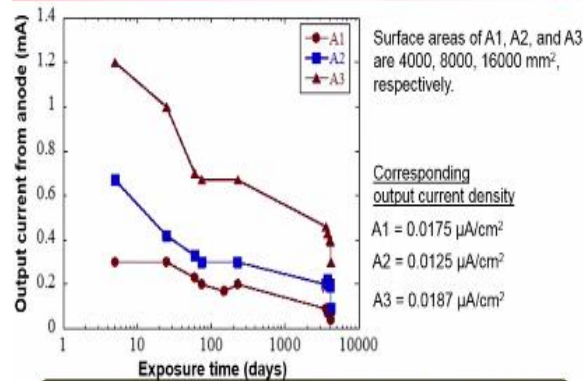
Output current from EACH anode

Sacrificial anodes were found active even after 12 years in the slabs with premixed chloride

So there is also one more current which we talk about, that it is the corrosion current or the current given by the anodes. So A1, A2, A3 are the anodes, 3 anodes which were used and all the anodes are still being very active in providing the current demand. So here one thing you have to remember is that, someone might think that the curve is slopping down. So what is happening, why it is going down? So you have to think that in sacrificial anode galvanic protection systems, the anodes provide the current which is being demanded by the steel. So it is a dynamic system. So what we have to think is, as the time passes, the steel gets passivated and then the demand for current is also going to be less. When the demand is less, then anode will provide only that much current.

So point to be noted is whether the anode is providing current or not. So let us not look at the magnitude of that current, but whether it is above 0 or not, whether it is able to provide the current which is demanded by the steel or not. That is the idea here. And as you see on the screen, all the 3 anode systems are still able to provide the current as demanded by the already passivated steel. So it is still working even after 12 years.

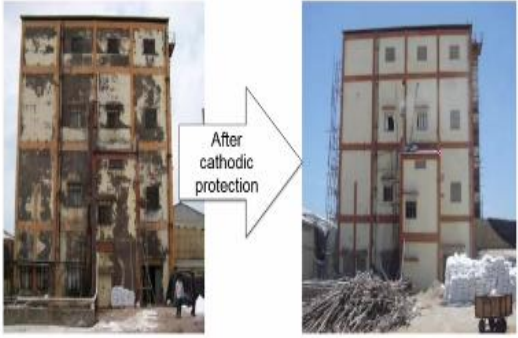
Case study 2
Salt processing factory building - Thoothukudi

Another case study is a salt processing factory building in Thoothukudi or Tuticorin. You can see the picture on the left side, it is in a corroded conditions. This is before the repair, and after the repair the structure was strengthened.

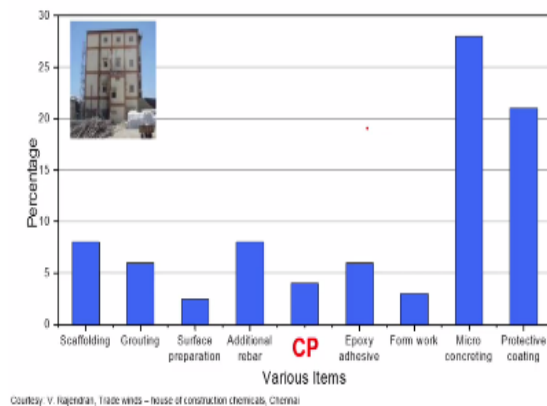
Total cost of repair was INR 27 Lakhs

- Cost of anodes was INR 1 Lakh (4% of total repair cost)

Now there is a myth that the cathodic protection system is going to cost more. But what in reality is, you can see on this chart for this particular project, we got the repair-cost data. For their entire repair work of this 4-storey building, you can see at the bottom, different type of project activities, scaffolding, grouting, surface preparation, additional reinforcement, CP (cathodic protection or anodes), epoxy adhesive, formwork, micro concreting and protective coating.

So these are all the different types of products and systems used for this repair work and you see that the cathodic protection cost only about 4% of the total repair cost, which is much less. So there is myth that cathodic protection means a lot of money, it is not really correct. And, in this project they have used micro concrete which accounted for almost 30% of the project cost and protective coating which is about 20%.

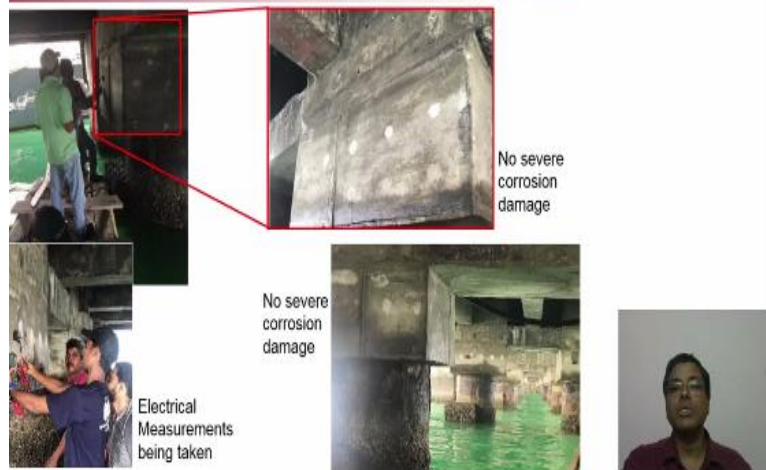
Inspection at the end of 12 years after the installation of galvanic anodes

But still, this was a project done 12 years ago. So, at that time probably it was very difficult to even get the authorities to agree for this kind of work. So anyway, so let us have this data right now, and some pictures here show how the monitoring was done. So we recently visited the site and then took some measurements and also some photographs. So photographs very clearly indicate on the right side, you can see the photographs, which says no corrosion, no major cracking. I am not saying no corrosion, but no major cracking, even after 12 years of service. So that is very good and picture on the bottom right also it clearly shows no severe corrosion damage after 12 years of service.

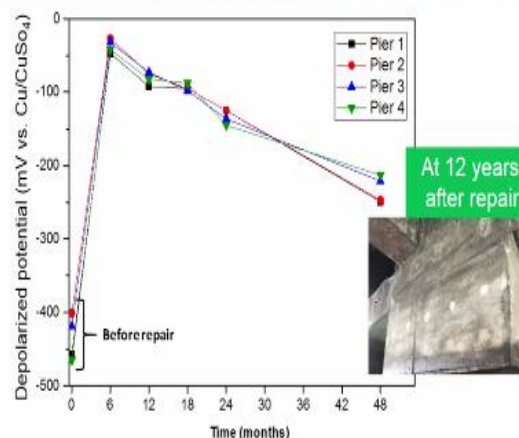
Depolarized potential measurements on finger jetty for about 4 years

Now this is the data how it looked. Depolarized potential, you can see even though it is getting more and more negative, but, the plot is only for about 4 years and we could not collect the data after that, but what you have on the screen, that photograph is taken after 12

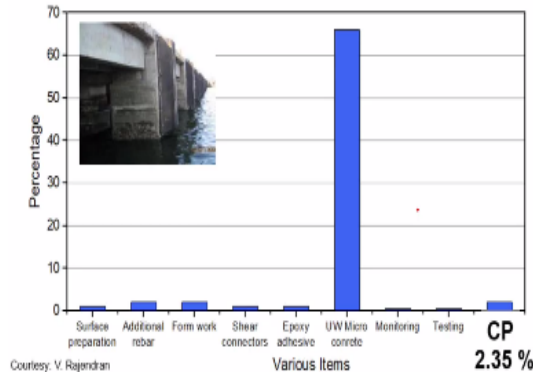
Total cost of repair was INR 2.3 crores

- Cost of anodes was INR 5 Lakh (2.35 % of total repair cost)

So cost factor, here again micro concrete is the largest cost and you have the anode cost just 2.35% of the project cost. So this anode cost is nothing, it is just that we need to have the will power and guts to actually start practising cathodic protection system. So it is not really affecting the capital investment of the repair, but definitely it is protecting the structure for much long period of time. That means the lifecycle cost is going to be much less, because we will not have to repair often.

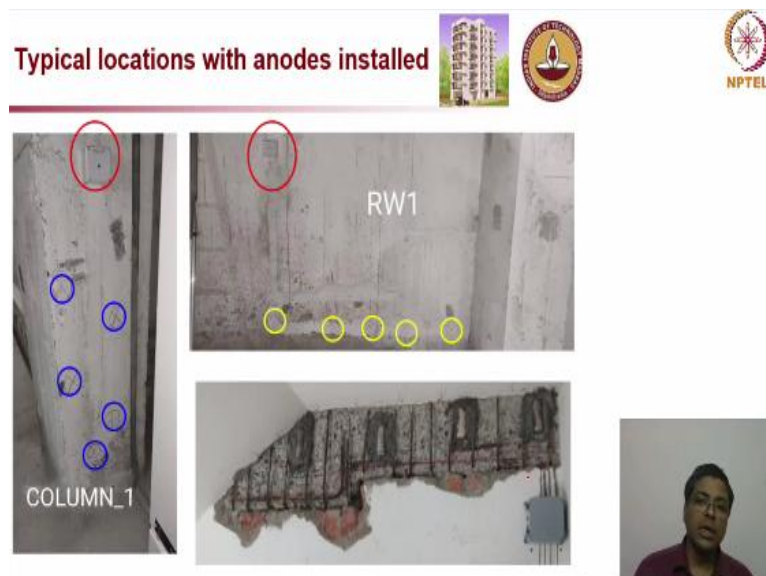
So these are some of the photographs showing columns and then other structures, and then on the bottom right you can see that is about a staircase where the anodes are installed. You can

also see a control or monitoring box on the bottom right, you can see that. So these were the example anodes installed to check the performance of the anodes.

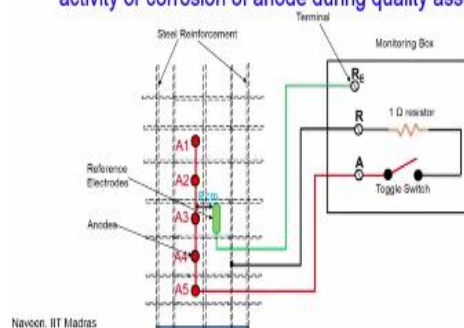
- 12 representative test locations
- Ability of anode to provide current when needed
 - RH of concrete varied from 60% to 80% and will affect the activity or corrosion of anode during quality assessment

So one more important thing I want to tell is, when we check the performance, this is how the anode performance is checked. You can see 5 anodes were installed and reference electrodes, which is the green mark over there which is kept very close to and embedded into the concrete, which is very important, so that you get a uniform data.

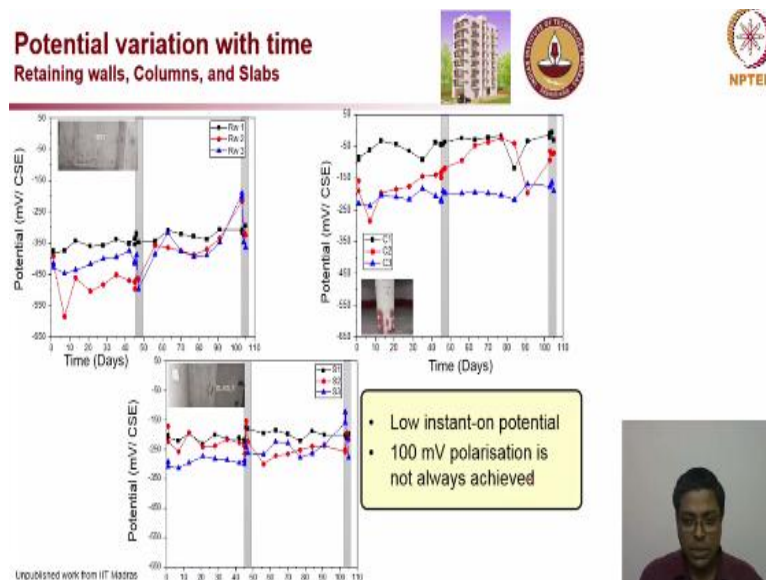
Now this is the potential, some data which we collected, and then here, why I put that is, instant-on potential is there, something which we call, means the moment the anode system is connected, you take a measurement. And then, generally there is a criterion that if there is a

100 millivolt (mV) shift in the potential, then the anode is good. This is a typical criterion which is practised in many places, but again this is not a necessary condition, in my opinion.

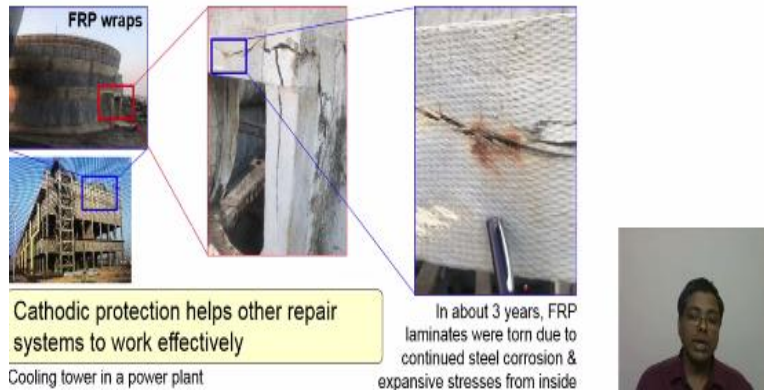
- FRP Wrapping + Cathodic Protection would have been a better choice of repair/strengthening

And one more thing I want to say, this is a demonstration of how an installation of cathodic protection could have saved this fibre wrapping. So this structure on the bottom-left image, it is not a clear image. But, you can see it is a cooling tower in a power plant and you have this funnels at the top; huge structure, very thin element, but very large in diameter. These are the cooling tower structures, in most power plants you will see this, and you can see a red square mark over there, which indicate the corroded region where the fiber wrapping was failed.

So you can also see on the top-left image, there is a wrapping; 3 rings, kind of, laminates you can see. They are installed, because this structure was experiencing lot of cracking due to corrosion because there is a lot of chloride-rich environment here, because this structure is right next to the sea shore. So it uses the sea water and then that water after the power generation, is cooled using this, so that is why we call it cooling tower. So this particular concrete structure is exposed to very rich chloride conditions and this structure corrodes very fast.
