Maintenance and Repair of Concrete Structures Prof. Radhakrishna G. Pillai Department of Civil Engineering Indian Institute of Technology – Madras

Lecture – 05 TM-Ring Test for Assessing: The Quality of TMT / QST Steel Rebars

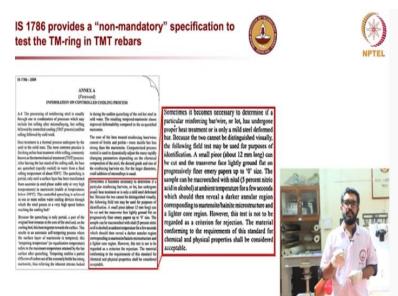
(Refer Slide Time: 03:48)

Now we have tested this in several rebars of different diameters and different sources. So, on the screen we have several different rebars being tested and show us the TM and the FP areas in it. So in most of the cases we find that the microstructure is inadequate where the TM ring is discontinuous, or the FP core is eccentric, and this is predominantly seen in 8 mm and 12 mm rebars. Now if we don't ensure the proper microstructure is present it can result in premature failure in terms of strength or premature corrosion.

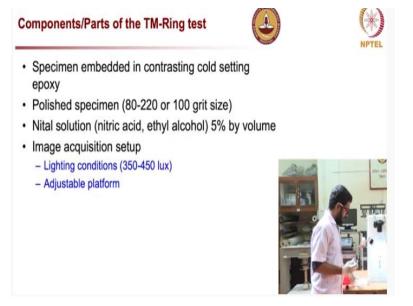
(Refer Slide Time: 04:12)

This is where TM rink test comes into picture where it used to ensure the durability of the steel in terms of proper heat treatment. This test is easy and replicable to do on site and it involves macro etching in it. This is more of an enhanced version of macroetching.

Coming to the test procedure, we have two parts, one is the specimen preparation and second one is the actual test procedure. For the specimen preparation we have a regular steel rebar which is cut into a small piece, this rebar will be polished using sandpapers of different grid sizes ranging between 80 to 220. Once polished we embed the specimen in a cold mounting epoxy which in this case has a contrasting color, this will help at the end when we take the photograph.

Coming to the test setup, we have a camera which is set at the top, we have two adjustable lighting and then there is a movable platform. On the movable platform stays the specimen. The adjustable lighting is set at 350 to 450 lux light intensity to make sure that we have replicable results. The movable platform is set to make sure that the specimen is entirely in focus in the camera.

Next, we have the solution which we are going to use for macro etching which is 5% Nital solution. The Nital solution is being made using nitric acid and ethyl alcohol. 5% nitric acid by volume in ethyl alcohol is being used in here.
