**Maintenance and Repair of Concrete Structures**  
**Prof. Radhakrishna G. Pillai**  
**Department of Civil Engineering**  
**Indian Institute of Technology – Madras**

**Lecture - 06**

**Corrosion of Embedded Metal (Coated Steel Rebars and Non-Metallic Rebars)**

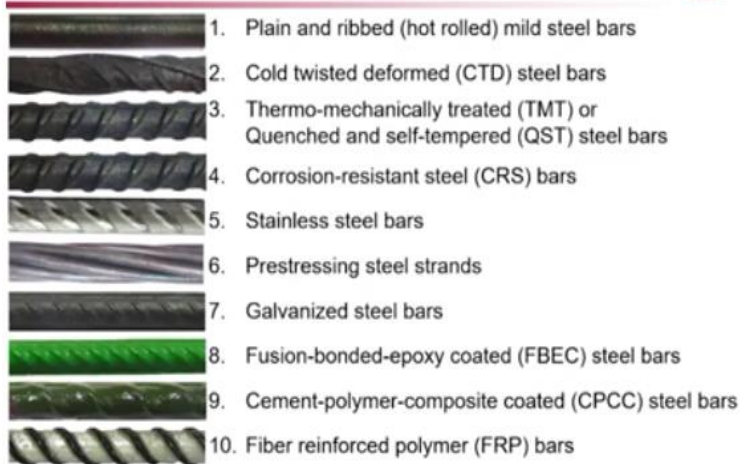
## Types of Reinforcing Bars/strands

So this is a recap and you have seen this slide already. So essentially, what we will cover today is this type 7, 8, 9 and 10, on galvanized steel rebar, fusion bonded epoxy-coated rebar, cement polymer composite coated rebar and fiber reinforced polymer rebars.

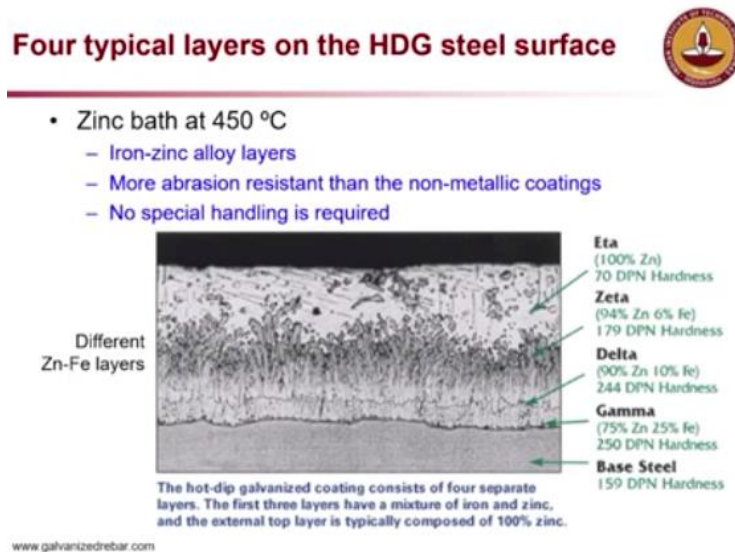
Now what is there in this zinc coating? Typically there will be four layers of the zinc, which is formed you can see here, this is the bare steel and then you have this very thin layer of gamma phase here and then another layer here and then you can see another border somewhere about here and then this is the pure zinc region.

So essentially, there are about four regions, which you can see in this. Because of this and the steel gets protected and main thing to note here is, even the outer layer you have about 70 DPN hardness, which is much better than typical non-metallic coatings and because of this high hardness, you needs no to be handled in a very delicate manner. You can handle as we do in a normal construction site. Rough handling does not really create much problem for this type of steel.

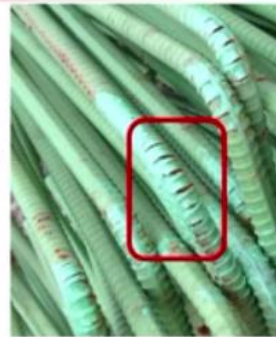
- Due to inadequate ductility, the epoxy coating can crack during the bending "at site"
- An additional coating (see brighter green color on photo ) is applied "at site" at ambient temperature conditions
  - Fusion bonding will not occur at ambient temperature conditions
  - Additional layer is not repairing the damage and is not in contact with the exposed steel

Additional epoxy coating using simple paint brush and at ambient temperature does not lead to fusion bonding and should be avoided

So this is how it is you can see here and these are the damages which are caused due to the pinching of the lever arm and also if the epoxy does not have good elastic property at the time of this bending, it will lead to cracks like this at the bend region. And these are bars which are just 90 degree bend and imagine if they are actually used for stirrups for earthquake resistant designs which would have to be bent to 135 degrees. So that is another problem. We should not bend

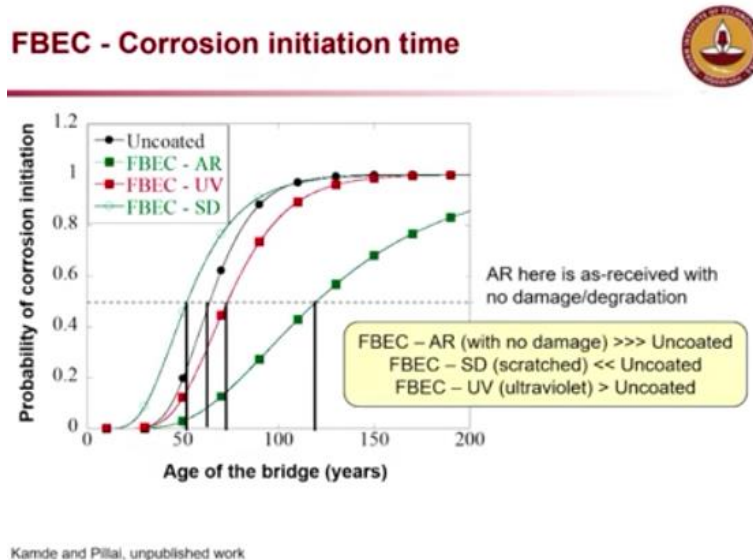
So what is the effect of all these on the service life or which we can say here as a corrosion initiation time or time taken for the chlorides to reach the steel surface and initiate corrosion. And here this AR means no damage or no degradation, as received good quality epoxy-coated rebars. So very clearly here, the uncoated bar which are the solid filled circular markers, we can say an average time taken for initiation.

And if the coating is very good, you can say you can easily get 100 plus years of life, but again when you look at this, they are just basically very close to each other. You cannot really say a lot of differences. So the message to be taken here is that epoxy-coated rebar or to be precisely

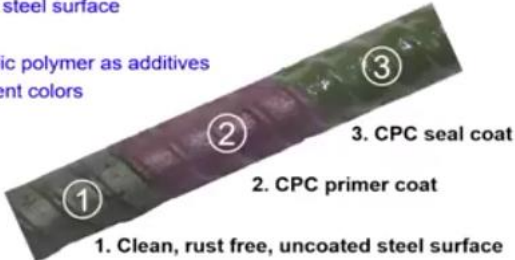
1. Rust free, sand-blasted steel surface
  - Provides large surface area to bond
  - Chemo-mechanical bonding between steel and coating
2. CPC primer coat
  - Cement with acrylic polymers as additives
  - Cementitious content helps to form a passive film on steel surface
  - Adheres well with steel surface
3. CPC Seal coat
  - Cement with acrylic polymer as additives
  - Available in different colors
    - Grey, Green, etc.

1. Clean, rust free, uncoated steel surface

2. CPC primer coat

Another type of non-metallically coated rebar which is widely used in the construction is this cement polymer composite or CPC coated rebars. Let us look at what is this rebar. You have three major processes. First you have to clean the rebar surface. The recommendation is clean it by a sandblasting which is sometimes very difficult to practice at most of the construction sites. So you have to really get a very clean steel surface and then you apply a primer coat on that steel surface which is item number 2 here and then on top you apply a seal coat which is item number 3 here.

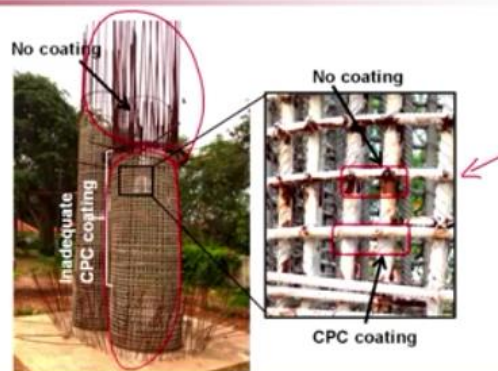
## Inadequate CPC coating on rebars

CPC coating with discontinuities & non-uniform thickness applied on corroded rebars - for coastal bridge columns

Now that is what I just discussed is the best practice and if you have a good coating, it will have long life, but if you have considering the way it is being done at the many construction sites, we are seeing a lot of challenges or trouble or concerns with the use of this type of coating. This picture was taken from a coastal bridge construction. You can see the piers and the cage for the pier of this particular bridge and what you see here is the top portion of this it is not at all coated. And only the bottom portion is coated here and that too was coated after the cage is made. When you are making something which is after the cage is made, getting the entire steel surface coated is very difficult. So ideally we should coat the steel surface and then make the cage, but in this particular case, it is done the other way. So what is the end effect is something like this as you see on the closer picture on the right you can see that some region is white in colour and some region is rust colour, the brown color. So definitely, there is a non-uniform or uneven or discontinuous coating. That is a challenge.

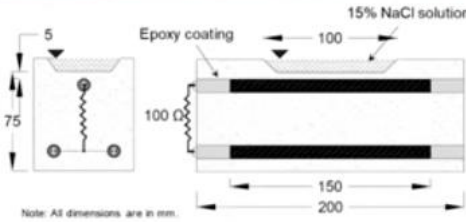
**Some observations from the corrosion tests performed at IIT Madras**

Note: All dimensions are in mm.

**Test variables and number of specimens**
