**Underground Space Technology**  
**Prof. Priti Maheshwari**  
**Department of Civil Engineering**  
**Indian Institute of Technology – Roorkee**

**Lecture – 60**  
**Few Case Studies**

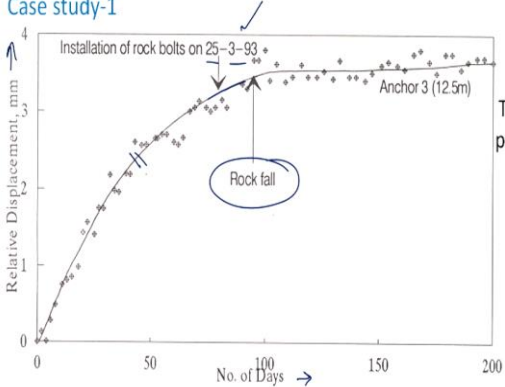
So, this is how the situation was there. Here on the x-axis, we have the number of days and on y-axis it was the relative displacement and this was the trend of the roof convergence at that particular site. So, the installation of the rock bolt was done in 1993 to the specific 25th of March and here, see this was continuously increasing indicative of the rock fall and then of course the support system was installed.

Let us take a look. There was a warning about the impending rock fault just because the sections were properly instrumented. So, the data that was obtained from the multipoint borehole extensometer which was installed in the roof at chainage 62.5 meters these were plotted with the time although the observation was started 303 days after the excavation of full cavern width at this section.

The roof convergence was still showing the continuous rising trend and, this was pointing towards the instability. Now, recall our discussion in the previous class. I mentioned to you that, based upon this trend of the deformation versus time, you can decide whether the rock mass is stable or unstable.

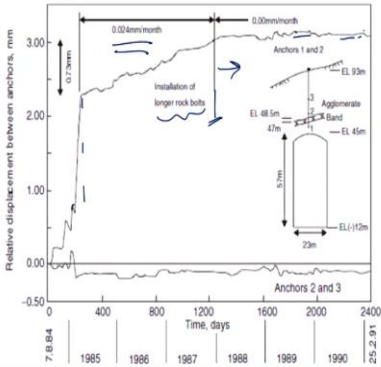
Stabilizing effect of longer rock bolts in power house cavern of Sardar Sarovar project

See, this is how the stabilizing effect of the longer rock bolts in the power house cavern was there. See, earlier it was all rising and beyond this time the rate was although small, but it was

rising. So, here they provided the longer rock bolts and, see what happens beyond that it is more or less stable, no more increase in the relative displacement between the anchors of the extensometer.

So, they decided to install the longer rock bolts to stitch the joints which resulted in stabilizing the rising trend. So, in this particular case study they took the help from the instrumentation and could avoid the collapse.

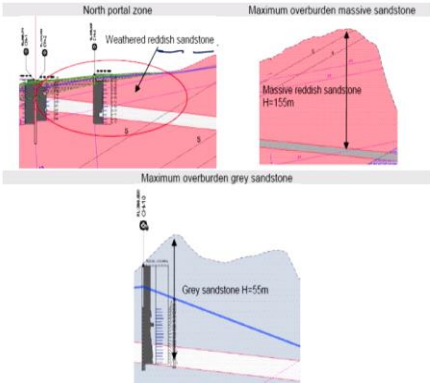
So, the strata was composed of the weathered reddish sandstone and, you can see the overburden also and the gray sandstone.

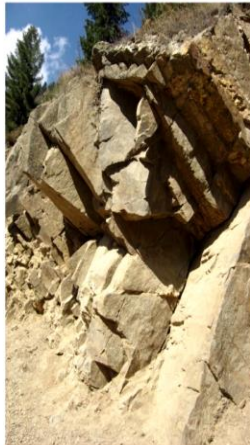
Moderately massive siltstones of Razdhan formation

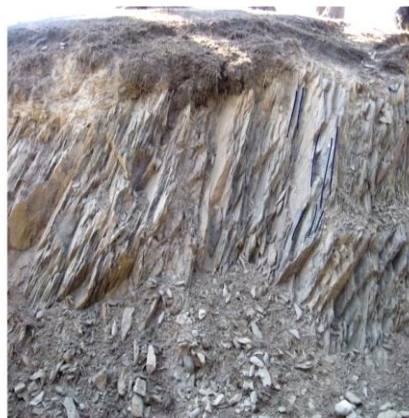
Meta-siltstones of Hasthoji formation: thinly foliated & excessive weathering close to surface
