Maintenance and Repair of Concrete Structures Prof. Radhakrishna G. Pillai Department of Civil Engineering Indian Institute of Technology – Madras

> Lecture – 07 Corrosion in Prestressed Concrete

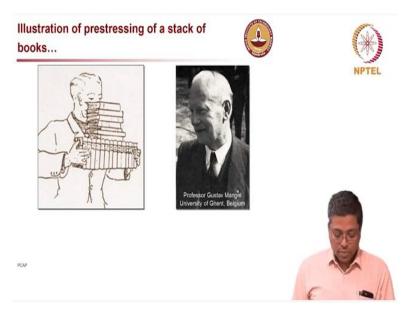
# (Refer Slide Time: 00:32)

I am going to show you very classical illustration of prestressing using some stack of books. You can see this is Professor Gustav Magnel's demonstration. He used to do it in class. Take a stack of books and then press it from the sides so that you can carry more load. So this is the same principle applied for prestressed concrete systems also where you have prestressing.

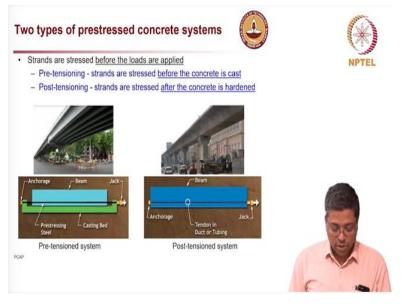
## (Refer Slide Time: 01:06)

There are two types of prestressed concrete systems, one is pre-tensioned system and the other one is post-tensioned system. The one on the left is a pre-tensioned system.

There are two types of prestressed concrete systems based on the time at which the strands are stressed if it is pretensioned concrete system then the strands are stressed before the

concrete is cast. In the post-tensioned concrete system, the strands are actually stressed after the concrete has achieved its strength or after the concrete has hardened.

So, one on the left which you might see these kind of bridges most of the flyovers in the city you might see this kind of systems most of them are actually pre-tensioned concrete. This is a typical metro on the right side. It's a typical metro bridge or elevated metro system where you will mostly see post-tensioned segmental concrete construction. Also I would like to mention if you see an I-girder it is not necessary that it's always like these kind of I-girders. It's not necessary that they are always pre-tensioned but there could also be post-tensioned system. (**Refer Slide Time: 02:29**)

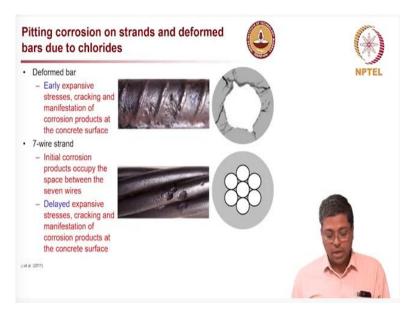
(Refer Slide Time: 03:09)

The pitting corrosion on strands and deformed bars are of 2 types or the type of corrosion which you see in the case of rebars and in the case of strands are little different especially the corrosion cracking patterns. So, for example in the case of typical rebar or a conventional deformed bar like in this case what happens is. You can see that some pits here and there.

But there are also regions which are not pitted much but the point here is there is no space like in the case of strands. Rebar is a single solid bar and the only surface which is corroding is actually in contact with the concrete. So, whatever the rust is formed it will very fast exert expansive stresses on to the concrete nearby leading to cracking and then followed by the oozing out of this rust through the concrete cover and then you can see that brown stains on the concrete surface.

But in the case of prestressed concrete system it's a little different what happens is. First because of the stress the pitting can be very significant or much localized and you can see very severe pits whereas some regions are not at all corroding or very limited corrosion. But you can actually have severe pits which might lead to the fracture of that particular wire. Like in this case this particular wire will fracture much earlier than the others which might lead to structural problems. And also on top of that whatever the rust is formed in the beginning they will occupy these small triangular shape spaces between the 7-wires. Once this space is fully filled with the rust only after that the rust on the strands will actually exert pressure on the surrounding concrete. So because of this what will happen is? There may be prolonged corrosion before you actually see some brown stains.

So, visual observation is not really a good idea when you talk about post tensioned systems. In the case of strands there could be delayed expensive stresses, cracking and manifestation of corrosion products.

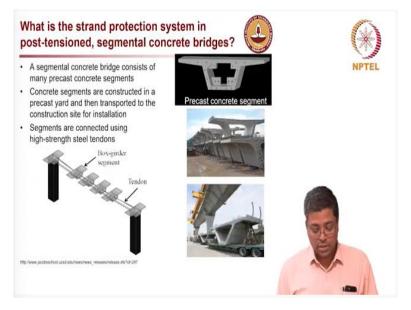
#### (Refer Slide Time: 07:40)

Let's look at what is the strand protection strategy or system in post-tensioned segmental concrete. As you see in this sketch here you have several box girders or the segments like in this picture you have 2 diaphragms and then 4 segments just to show but there will be more just to make it clearer to understand I have put it something like this. And then you have tendons which run from 1 pillar to the other. Typical simply supported systems will be something like this.

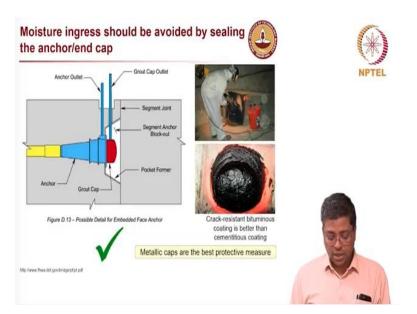
(Refer Slide Time: 14:50)

And on top of the metallic cap you also should have very good concrete element which will protect it. You need to really take care of the anchorage zones otherwise these structures will have severe corrosion problem in very short period of time.

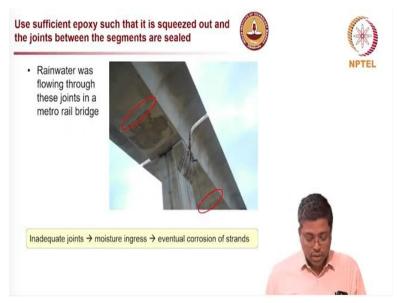
# (Refer Slide Time: 15:10)

Now, these are the segmental joints, the joints we can see here. So these joints usually are supposed to be filled. Earlier few decades ago people used to go for dry joints means there is nothing in between the 2 segments. You just keep the 2 segments together and then you know press it or due to the prestressing action itself and then rely on the shear keys for the resistance.

However, later on people found that it leads to severe corrosion because through this dry joint oxygen and moisture can penetrate and will lead to localized corrosion of the strands which are going like this. So this region will actually corrode. So, to prevent that recently people are actually using epoxy joints. That means you put epoxy on the facing surface of both the segments and then push them together and squeeze it.

Because of prestressing it will get squeezed and it is supposed to fill the entire region and to prevent the entry of moisture and oxygen it is very important. But we have seen if you do not really put a good amount of epoxy it will actually lead to further leakage and corrosion later on.

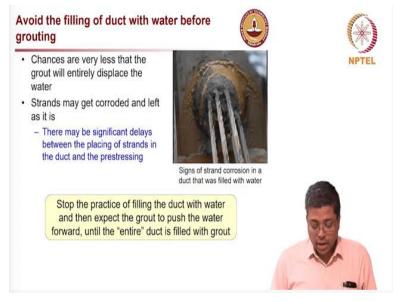
# (Refer Slide Time: 17:44)

There used to be a practice of filling the duct with water before the grout is filled in and then expecting that the grout will actually displace the water and prevent the formation of air void. This was the idea for going for practicing filling the duct with water. But it is not really a good idea because the strands might get corroded and the type of water which you use if it has a lot of chlorides that might also affect. So, because of this nowadays it is not recommended to fill the duct with water before filling the grout, okay. So you can see here this picture was taken from one of the sites where this was actually practiced as you see here the colour of this grout it is not grey, it has a lot of rust getting mixed with it. So it is a proof that the strand inside has corroded to some extent. So that is something which needs to be avoided.

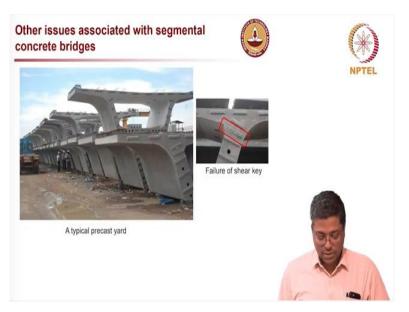
(Refer Slide Time: 19:20)

And then also the shear keys it is leading to this you can see an example where a shear key is lost and you know it does not really have a good shear resistance, this might really affect the shear capacity of this.

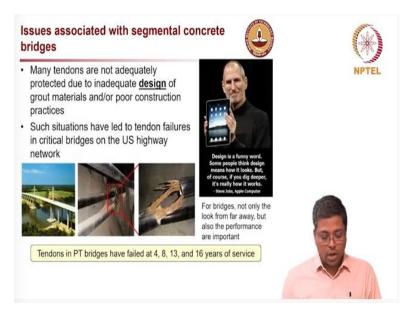
### (Refer Slide Time: 21:15)

What are the issues? Mainly the tendons are inadequately grouted and hence they corrode prematurely. In this picture here this bridge actually failed after the tendons were refilled with grout and in a very short period you can see here within about 15 years they started experiencing corrosion which is not at all expected in these kinds of bridges which are designed for 100+ years.

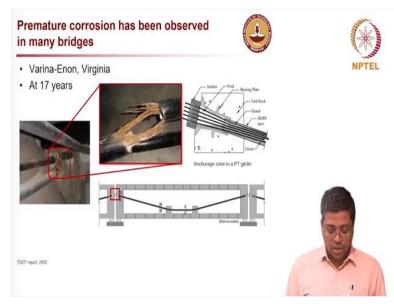
# (Refer Slide Time: 21:47)

Now, where is the corrosion actually happening? You see the profile here and then what is happening is, the cement in the grout will segregate, cement will move downward and water will move upward. So cement will move downward; water will move upward and then basically it segregates and then you see lot of bleed water will form at the top portion of the tendon like it is shown in this close up.

Then eventually that bleed water will evaporate. So you can see this unshaded or the white region is supposed to be filled with grout but it is not. So that will lead to additional problems.

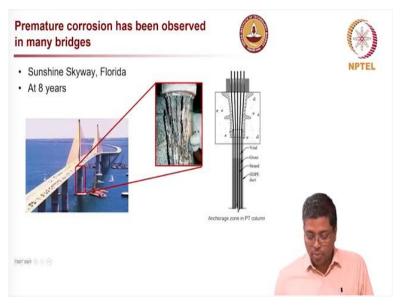
## (Refer Slide Time: 22:33)

This is another bridge where you can see a vertical tendon like in this pillar where this portion here is not at all grouted. So that is also leading to severe corrosion as it was visible in about 8 years this strand system completely corroded which is again very early corrosion. (Refer Slide Time: 22:54)

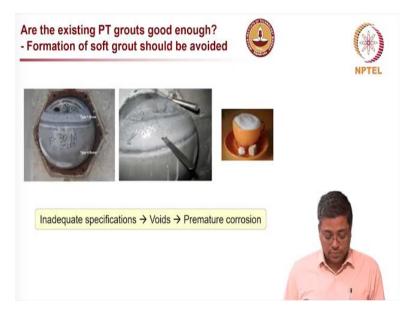
Now in the market today due to the significant void formation people have worked on developing better quality grouts. Better quality means grouts which can actually fill the tendons much better. But even in some of those grouts we see a new type of problem which is the soft grout formation where the inert materials which are used in this grouts were floating and it forms this soft grout as you see here very porous in nature and which can actually absorb the moisture and keep it there.

So it is like froth in a coffee cup. I mean on top of the coffee very porous, very low strength which can absorb moisture keep it there and then lead to corrosion of the strand.
